AQUATIC ENVIRONMENT  
OF  
HUMBER BAY

JUNE 1988

Edited by M. Griffiths

Water Resources Branch  
Ontario Ministry of the Environment

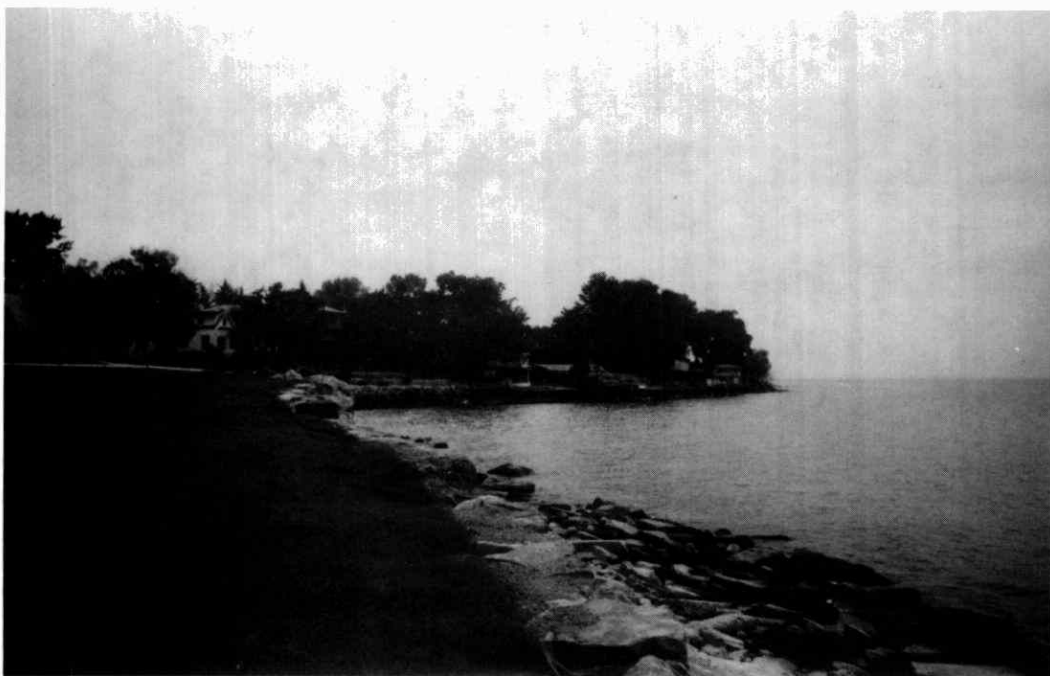
Boulders armouring this Etobicoke shoreline of Humber Bay provide a perfect substrate for the growth of a nuisance filamentous alga Cladophora.

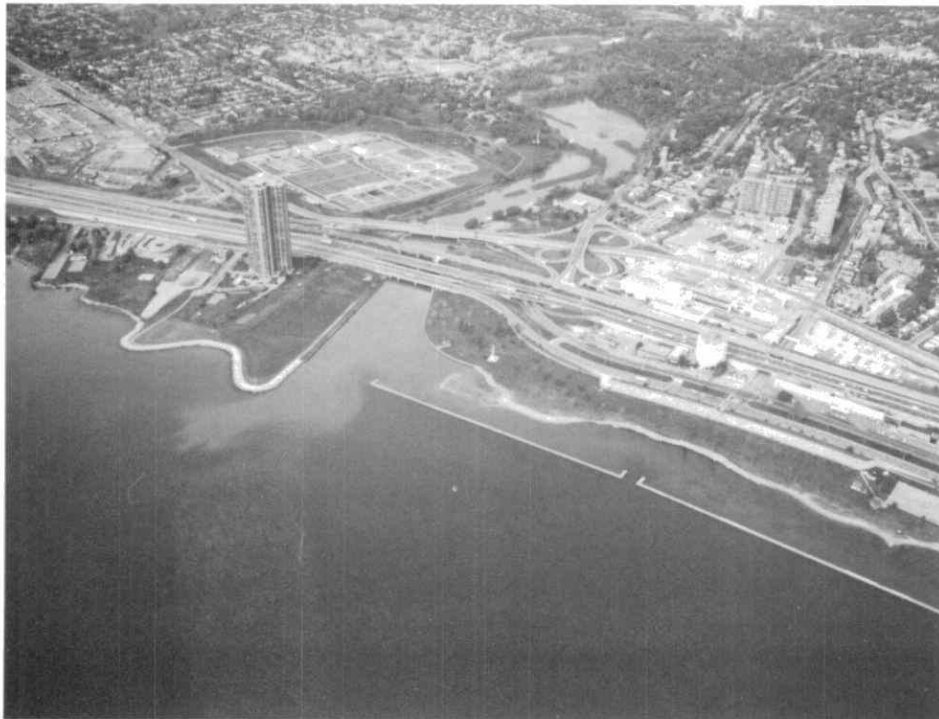
Humber River plume: Oct 18, 1983  
 Note its intrusion behind the  
 breakwall prior to the construction of  
 a deflecting jetty.

The first evidence of the Humber River plume affecting the inner breakwater water quality came from aerial photographs. The surface river turbidity plume was observed to enter the breakwater at the river outlet and move eastward. A deflector jetty was constructed at the river mouth in late 1984. The jetty did not close off the breakwater gap entirely.

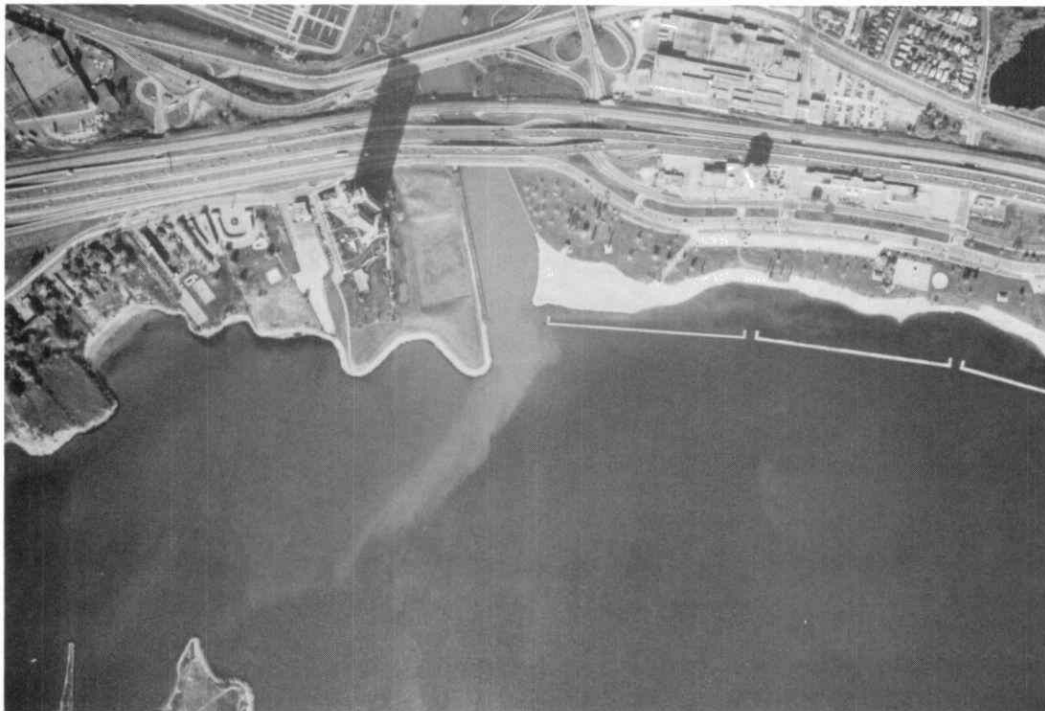
Humber River plume: Oct. 29, 1984  
 Note the newly constructed jetty on the east side of the  
 river mouth which now deflects the river away from the beach  
 area. The dark circular blob visible in the bottom left of the  
 photograph is the plume from the Humber STP which is impinging  
 on the Humber Bay waterfront area.
